Manhole Inspection Summary

Manhole # S45G2_010MH

Location Address: **4220 Prudence St**

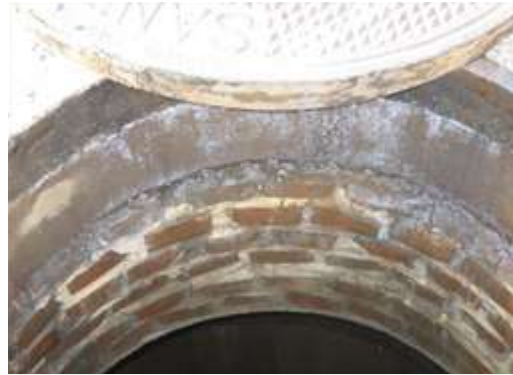
Defect 1

Offset: **0.5** (in.)

Frame offset

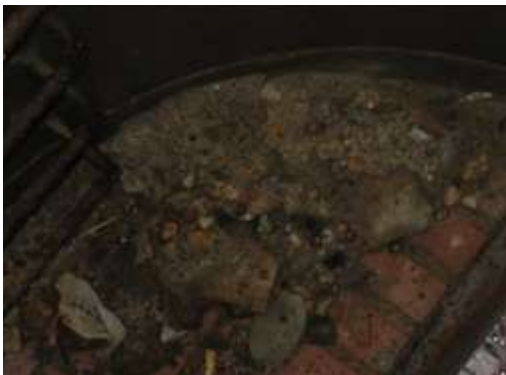
Defect 2

Debris

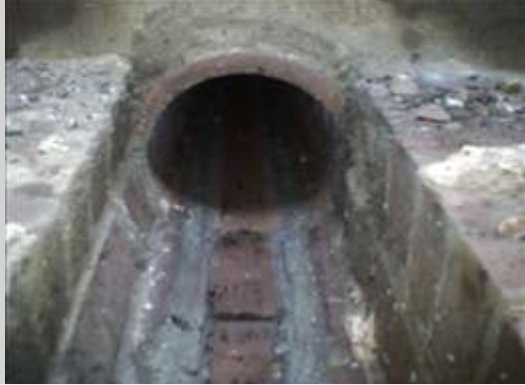
12 O'Clock Outflow

8 in. Circular Gravity Sewer
Pipe Out @ 12 O'Clock

Pipe Height: **9.6** (in.) Rod and Bar (Angled)
Pipe Material: **Clay** ☐ Pipe Lined
Invert Depth: **10.88** (ft.) Flow Characteristics: **Slow**
Deposits: ☒ None ☐ Mud ☐ Sludge ☐ Debris ☐ Grease
Silt Depth: (in.) Deposits Extent:
Infiltration: **None** Pipe Seal Cond: **Sound**

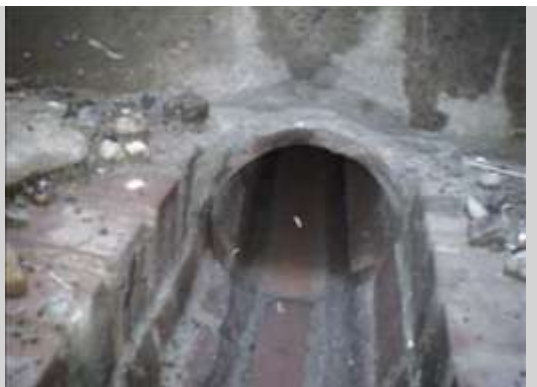
6 O'Clock Inflow

8 in. Circular Gravity Sewer
Pipe In @ 6 O'Clock

Pipe Height: **9.6** (in.) Rod and Bar (Angled)
Pipe Material: **Clay** ☐ Pipe Lined
Invert Depth: **10.87** (ft.) Flow Characteristics: **Slow**
Deposits: ☒ None ☐ Mud ☐ Sludge ☐ Debris ☐ Grease
Silt Depth: (in.) Deposits Extent:
Infiltration: **None** Pipe Seal Cond: **Sound**
